Final Report for Energy Performance of Straw Bale Buildings Research Program

December 12, 2011

Final Report for Energy Performance of Northeast Straw Bale Buildings Research

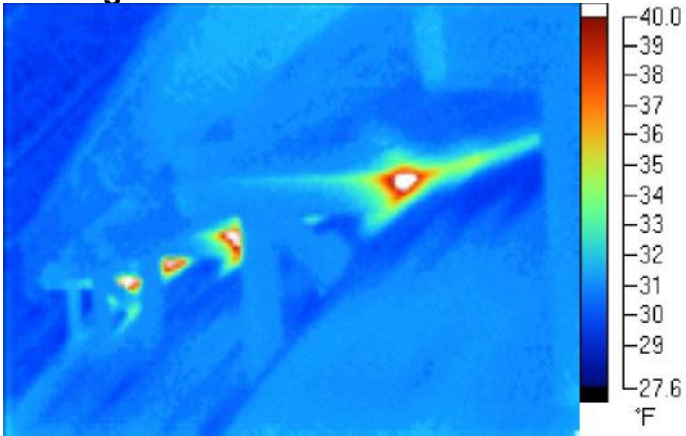
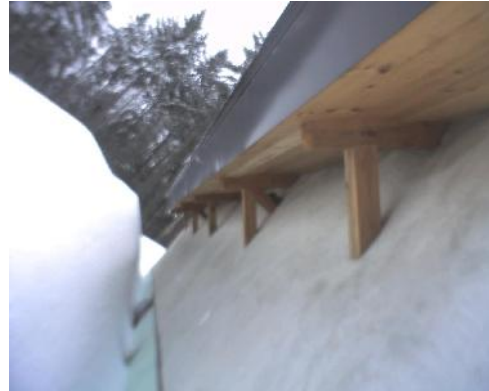
IR20110310_0446.is2

This is looking at the east eaves (at an angle). Warm air is leaking out at each rafter tail, with the warmest spots at about 48 deg.F. The blower door is NOT running.

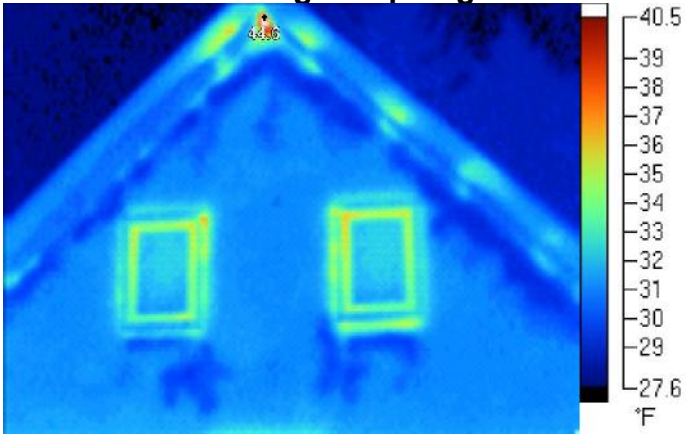
IR20110310_0459.is2

Warm air exfiltrating at top of gable wall – blower door is NOT running

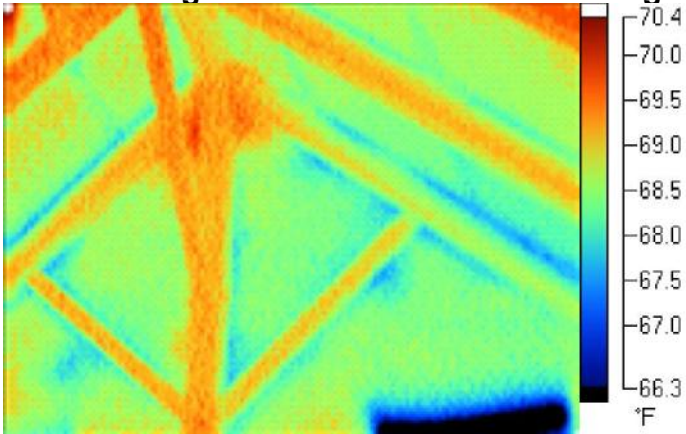
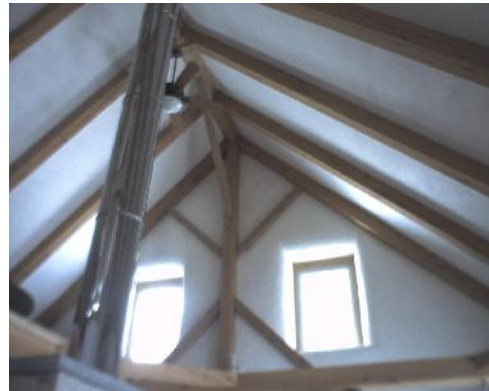
IR20110310_0465.is2

You can't see it with IR from the inside, but warm air is leaking out at the top of the gable wall (blower door NOT running). The top of the wall and posts are at about 69 deg.F and the wall is about 68 deg.F.

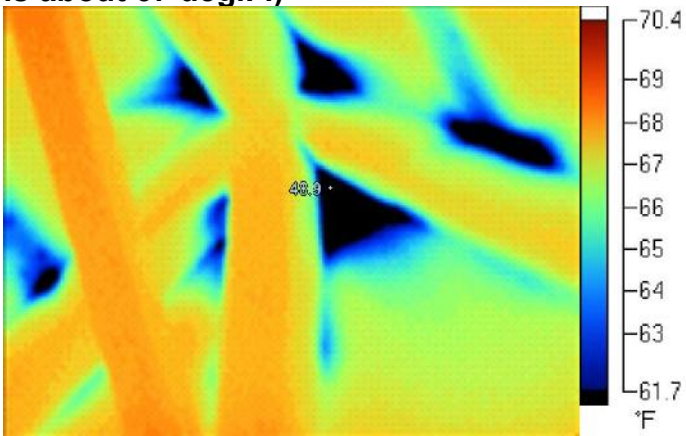
IR20110310_0491.is2

The blower door is now blowing OUT and the cold air is coming back in at the top of the gable wall. The coldest part of the wall is now 49 deg.F (the rest of the wall is about 67 deg.F.)

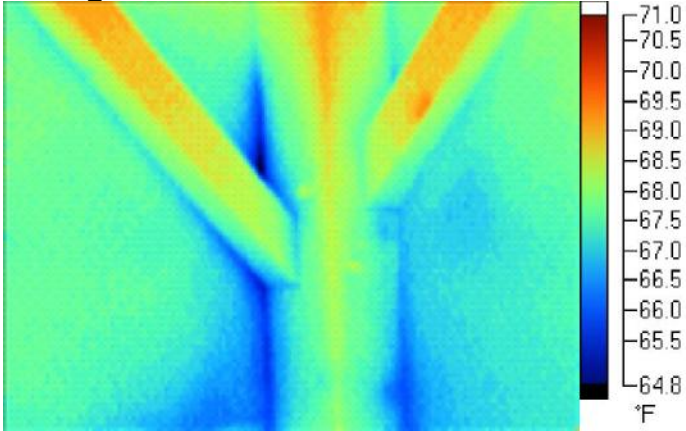
IR20110310_0463.is2

This is a corner post, without the blower door running. The coldest spot is about 64 deg.F.

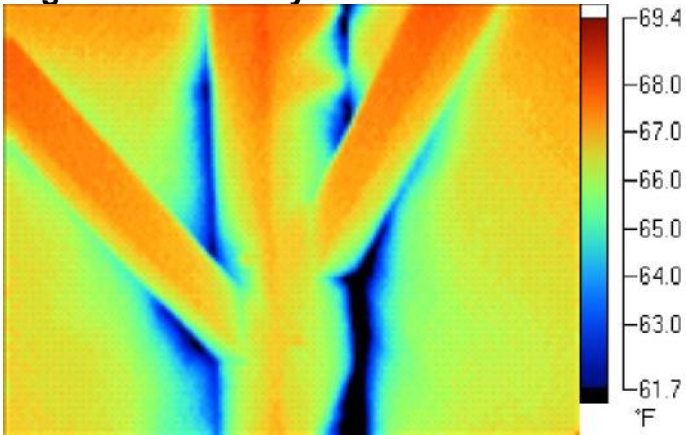
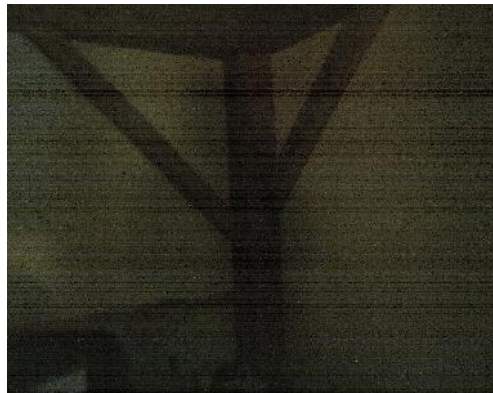
IR20110310_0480.is2

Here is the same corner post with the blower door running. The coldest spot is 57 deg.F. Not too leaky.

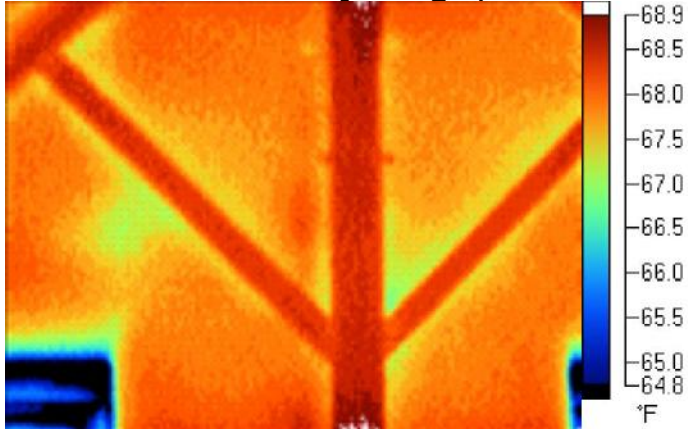
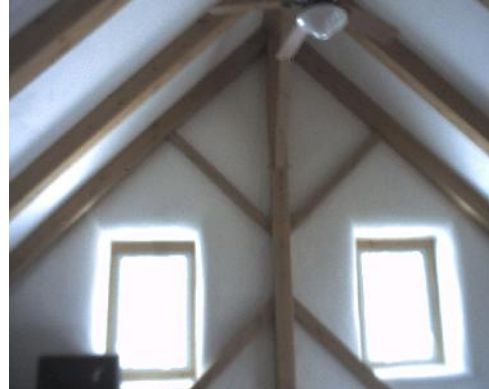
IR20110310_0469.is2

This is a post in the gable end wall. There do not appear to be any leaks here (the thermal window is only 4 deg.F). The blower door is NOT running

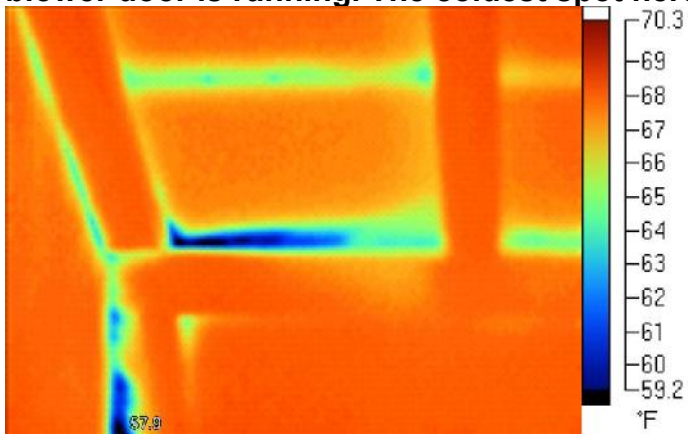
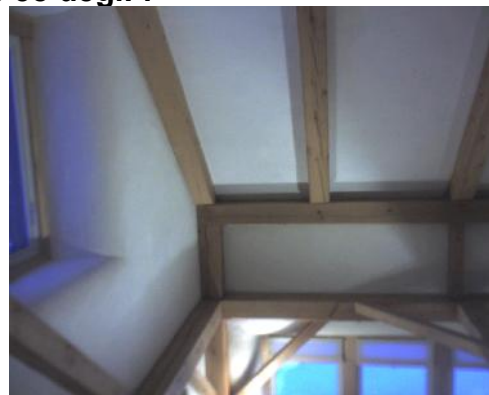
IR20110310_0488.is2

Here is some air leakage at posts and beams at the corner, but not a lot. The blower door is running. The coldest spot here is 58 deg.F.

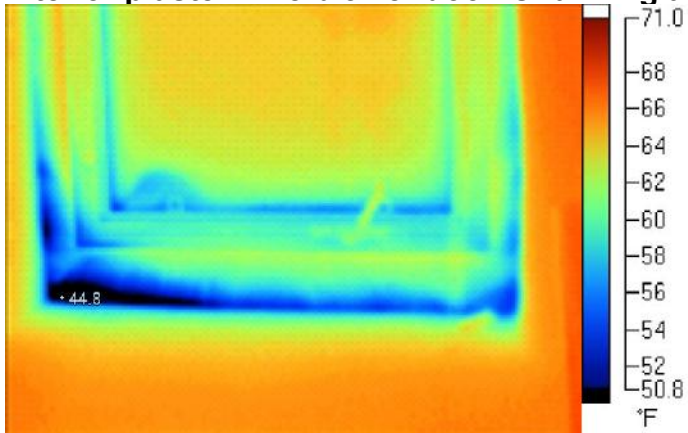
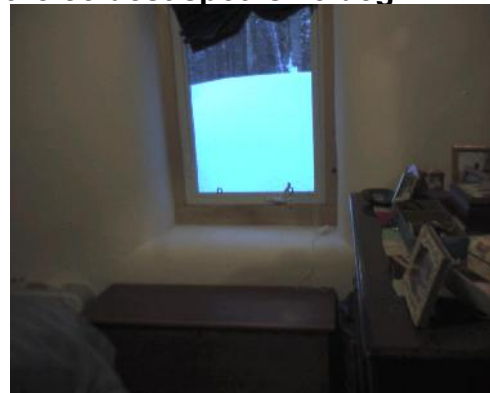
IR20110310_0482.is2

This is a classic IR image of air infiltration. It is between a window jamb and the interior plaster. The blower door is running and the coldest spot is 45 deg.F.

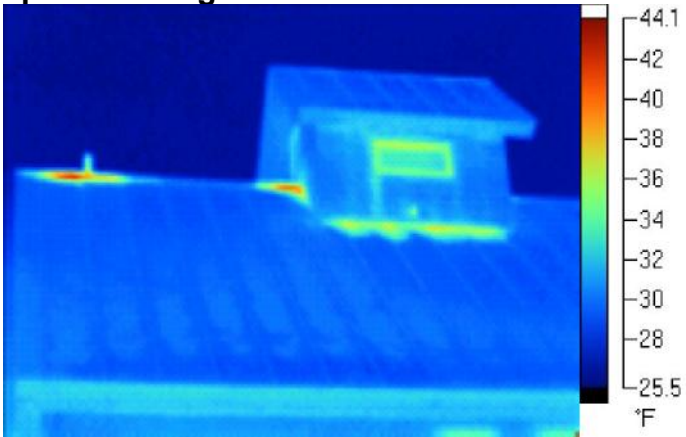
IR20110316_0531.is2

Heat loss at cupola and vent stack pipe. Blower door is NOT running. Warmest spot is 44 deg.F.

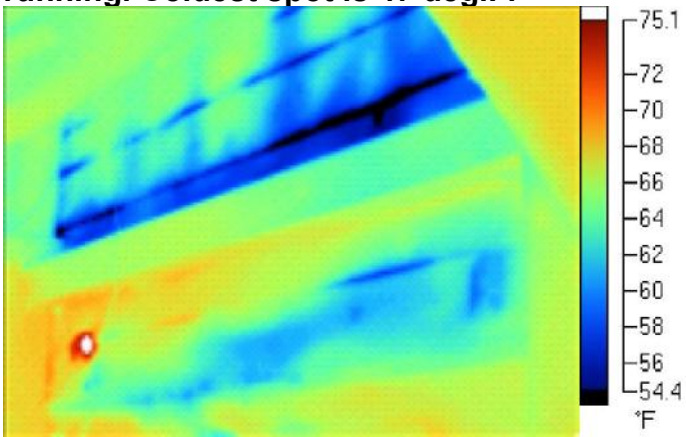
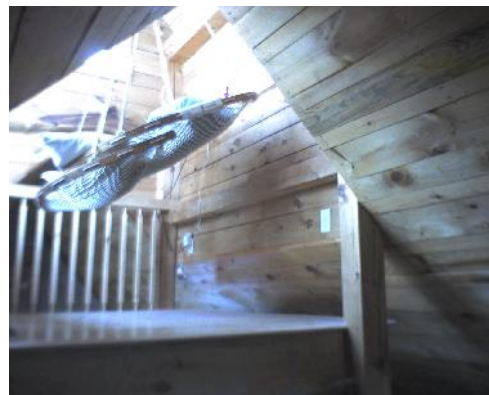
IR20110316_0622.is2

Air is now leaking IN to the south side of the cupola, with the blower door running. Coldest spot is 47 deg.F.

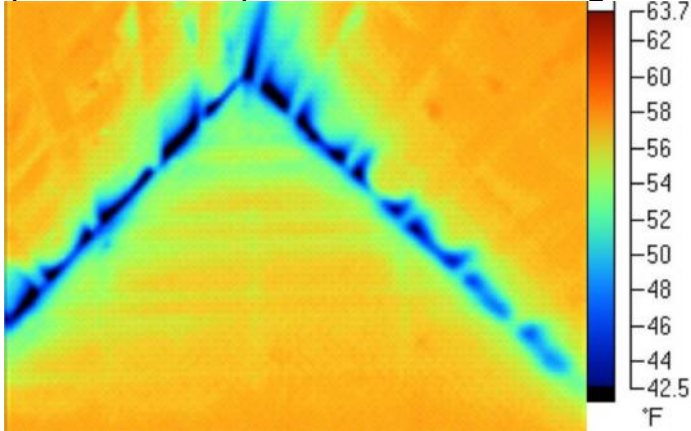
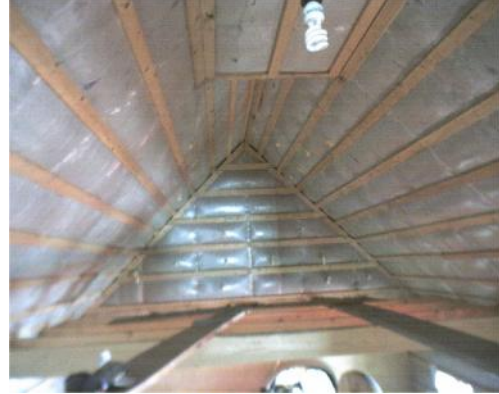
IR20110316_0658.is2

Cathedral ceiling of large mudroom, with plastic only. With blower door running, there is a lot of leakage at the top of the gable wall, which is why strapping is bad (see comments). Coldest area is 37 deg.F

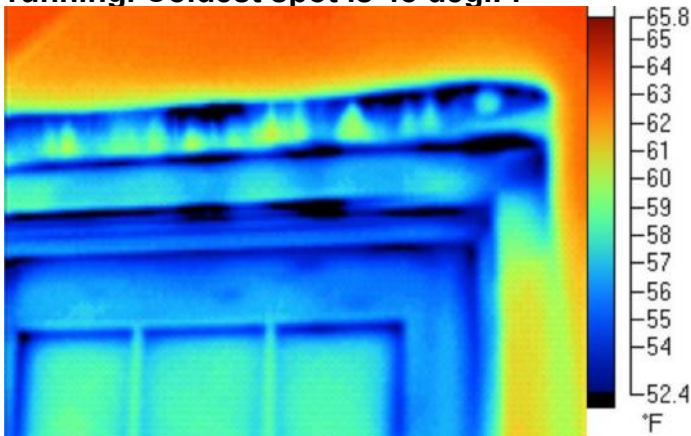
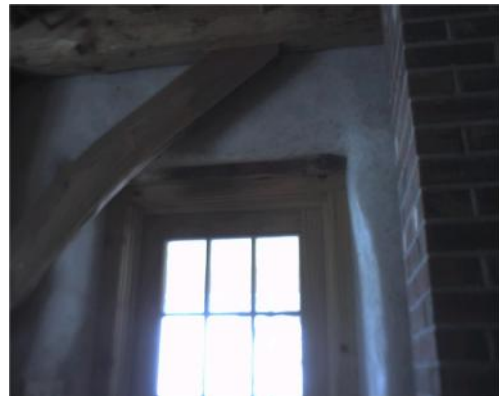
IR20110316_0603.is2

Air infiltration at west entry door, around jamb and lintel, with blower door running. Coldest spot is 48 deg.F.

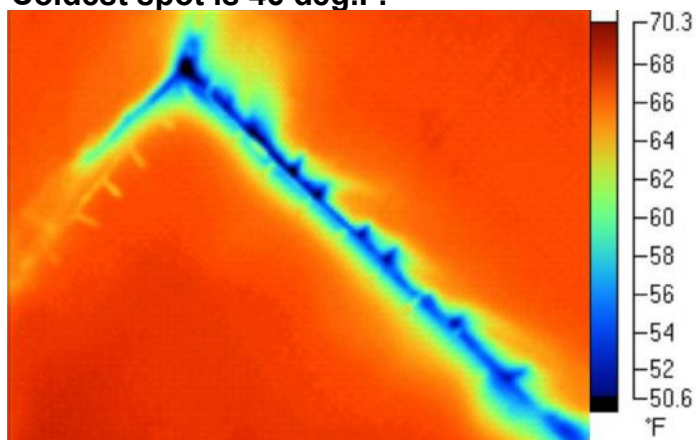
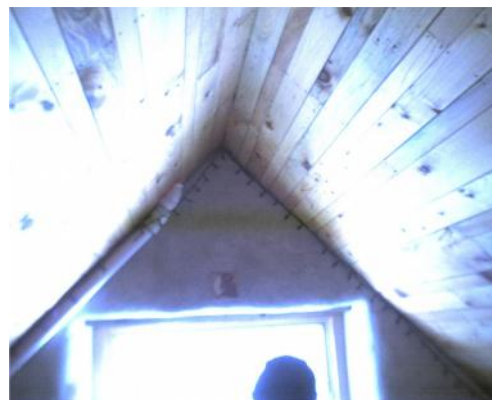
IR20110316_0620.is2

This is the east gable end of the main house, with the blower door running. Coldest spot is 46 deg.F.

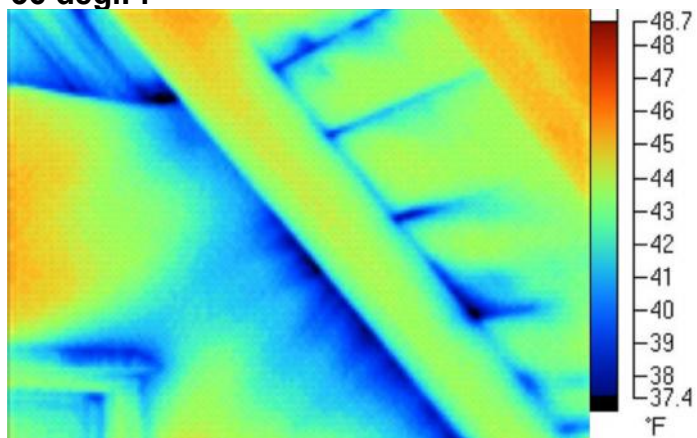
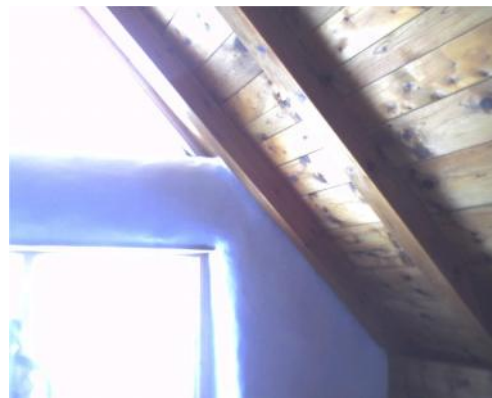
IR20110316_0673.is2

Air leaks at gable end of original house, with blower door running. Cold spot is 36 deg.F.

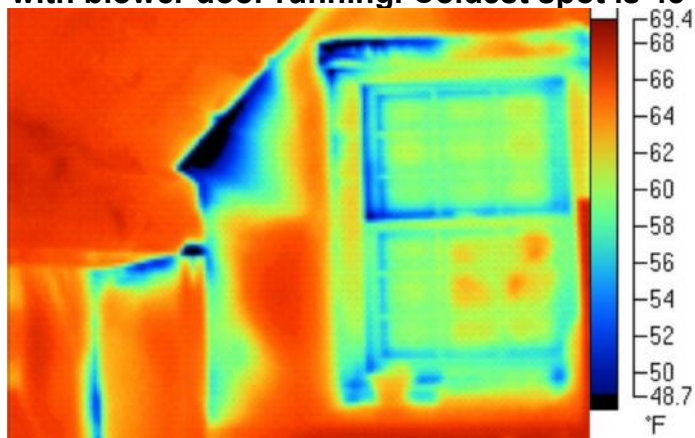
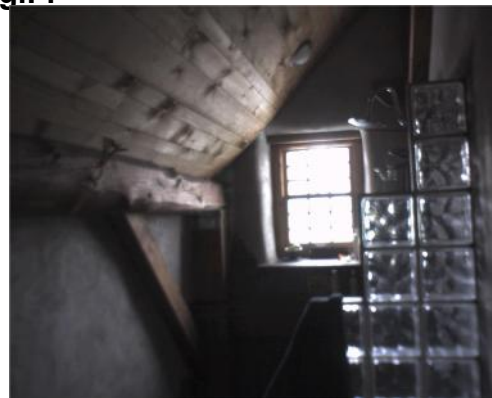
IR20110316_0615.is2

Lots of air leakage at rolled beam in east bathroom, and at top of window at lintel, with blower door running. Coldest spot is 43 deg.F.

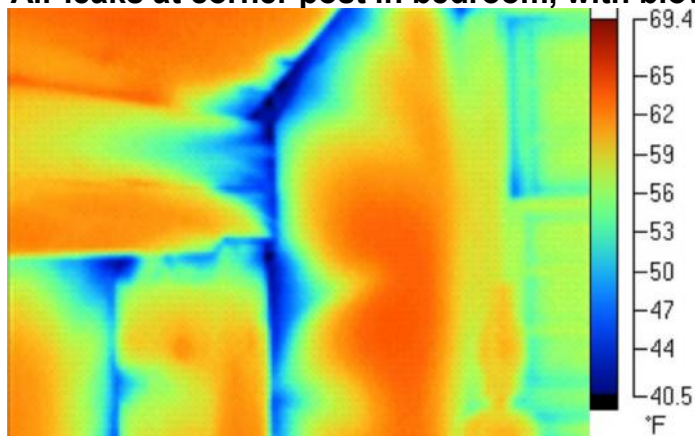
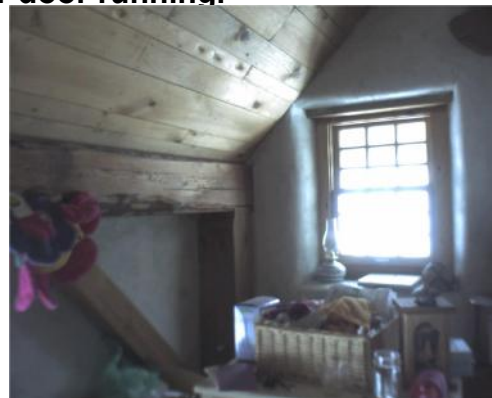
IR20110316_0643.is2

Air leaks at corner post in bedroom, with blower door running.

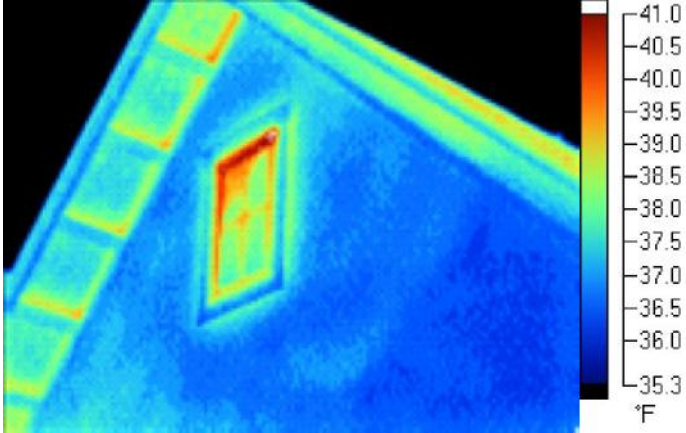
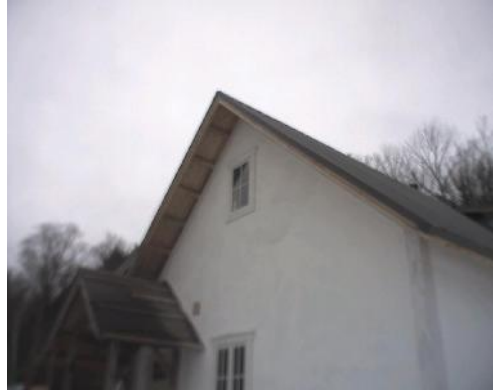
IR20110316_0681.is2

Top of gable wall shows essentially no warm air leaking out. Blower door is NOT running. Warmest spot is 40 deg.F (ignore the window).

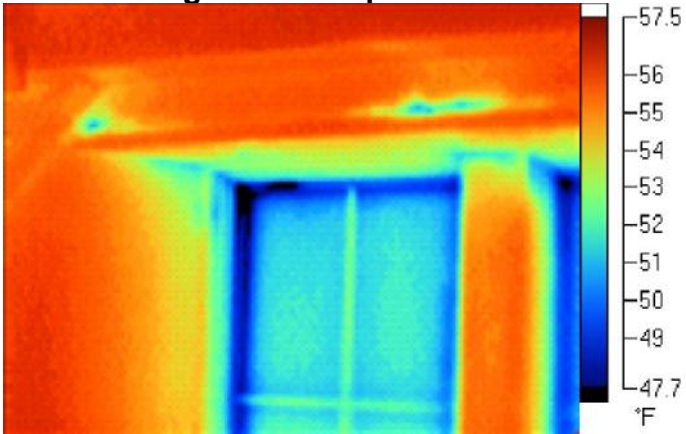
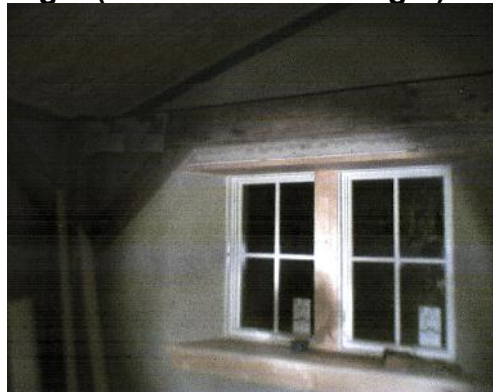
IR20110316_0741.is2

Window in NE bedroom (1st floor) shows very little air infiltration with blower door running! Coldest spot above window is 51 deg.F (wall is about 56 deg.F)

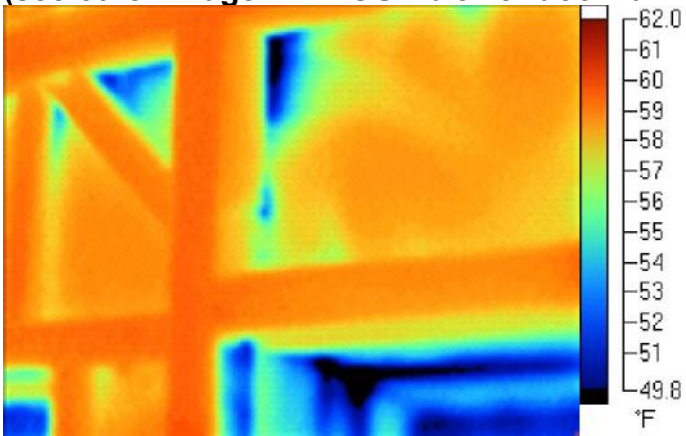
IR20110316_0749.is2

South wall framing above door, blower door is running. Coldest spot is 48 deg.F.
(see other image WITHOUT blower door running)

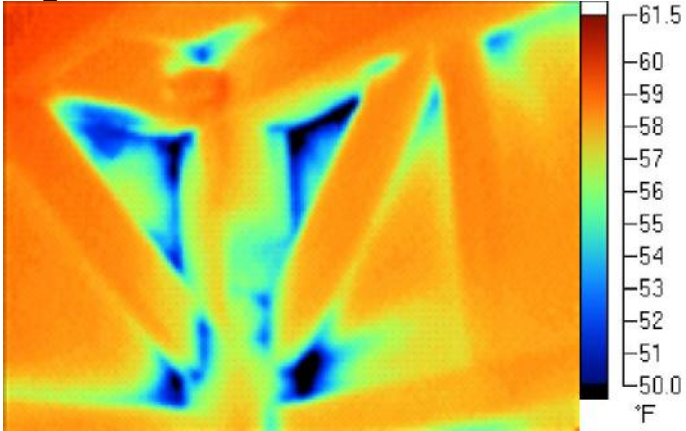
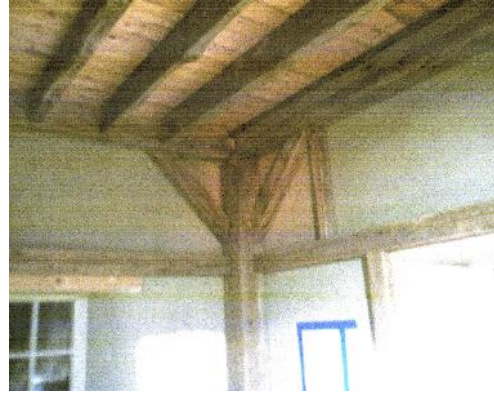
IR20110316_0745.is2

Air infiltration at SE corner posts, with blower door running. Coldest spot is 47 deg.F.

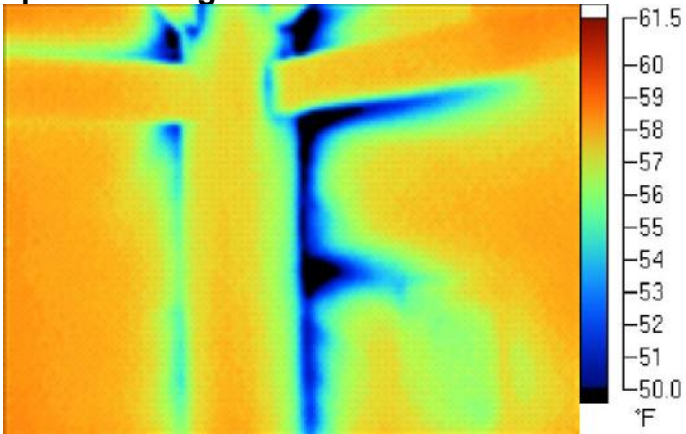
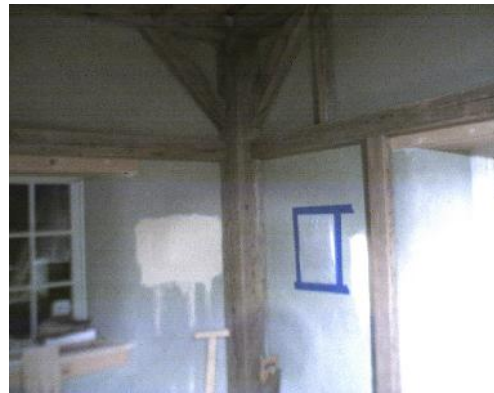
IR20110316_0746.is2

Air infiltration at SE corner posts, lower part, with blower door running. Coldest spot is 45 deg.F.

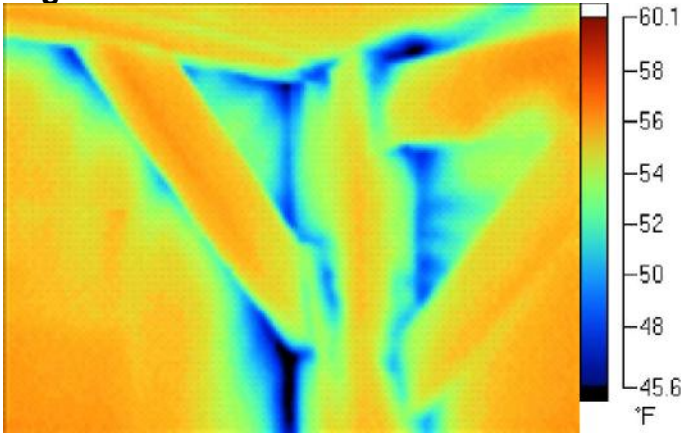
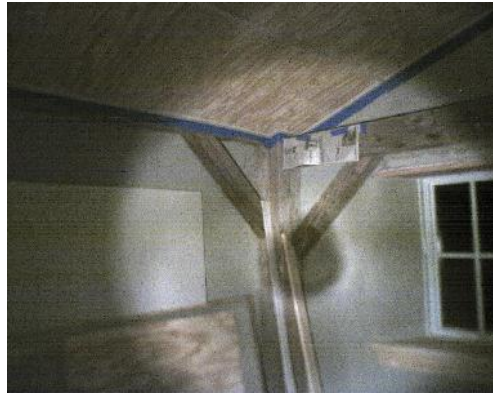
IR20110316_0740.is2

Air infiltration at NE corner posts, with blower door running. Coldest spot is 43 deg.F.

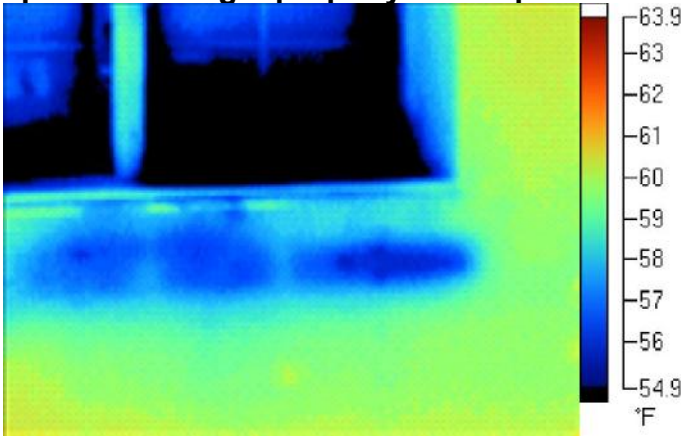
IR20110316_0761.is2

This area below an upstairs (north) window is about 5 deg.F below the surrounding wall, with the blower door running. The rough opening for the window had been made smaller. It may be an indication that the small framing space did not get properly dense-packed with cellulose.

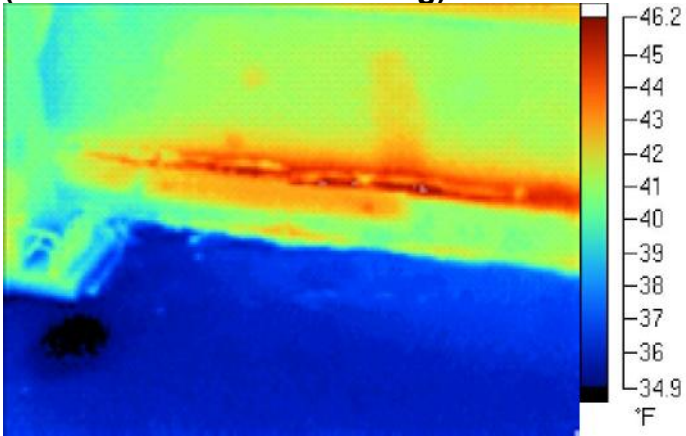
IR20110331_0843.is2

Heat loss at top of stem wall, which is sitting several inches above the concrete slab of carport. Warmest spot is 46 deg.F, while rest of wall is about 41 deg.F (blower door is NOT running)

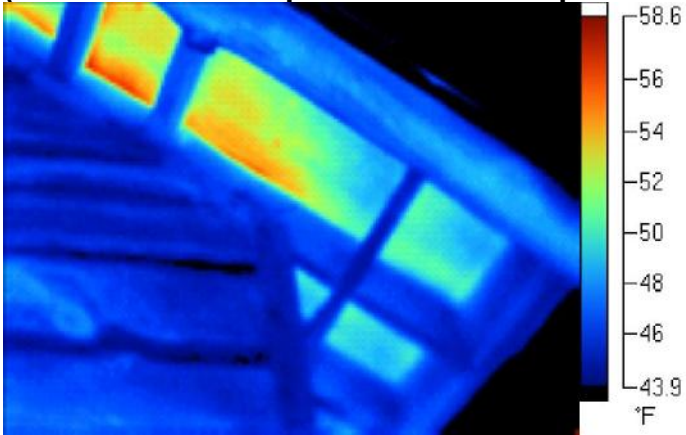
IR20110331_0862.is2

Heat loss at rake, top of east gable wall. Blower door is NOT running. Warmest spot is 57 deg.F, while rest of wall is about 45 deg.F. (This is an 18" deep wall with dense-packed cellulose)

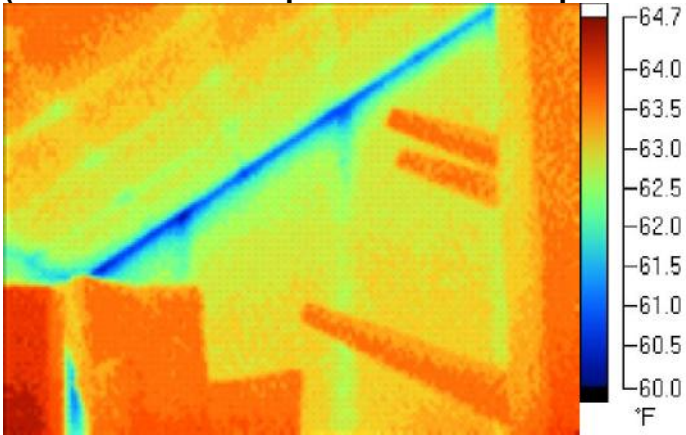
IR20110331_0877.is2

Top of east gable wall (this is the interior view of where heat loss was seen at exterior rake above), with blower door NOT running. Not a lot of temperature difference here. Coldest spot is 60 deg.F, with rest of wall at about 63 deg.F. (This is an 18" deep wall with dense-packed cellulose)

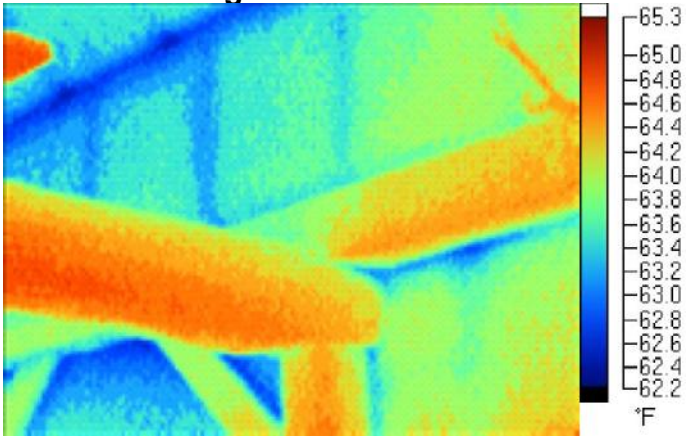
IR20110331_0868.is2

This is the post and beam in the middle of the north wall, with NO blower door running. Maximum temperature difference of wall in this area is only 2 degrees, which is not significant.

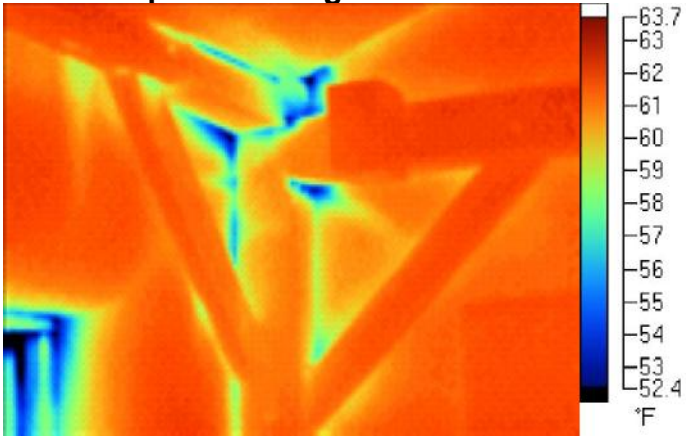
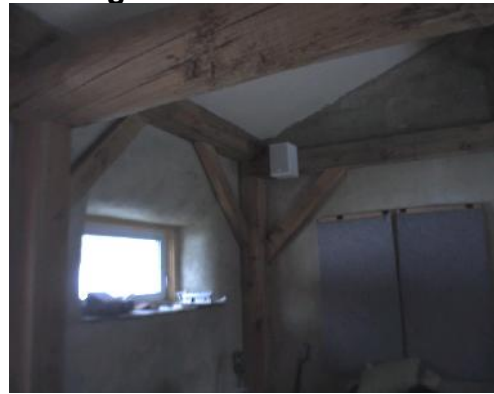
IR20110331_0879.is2

Air leakage at corner post/beams in SW corner, WITH blower door running. Coldest spot is 51 deg.F and rest of wall is about 62 deg.F

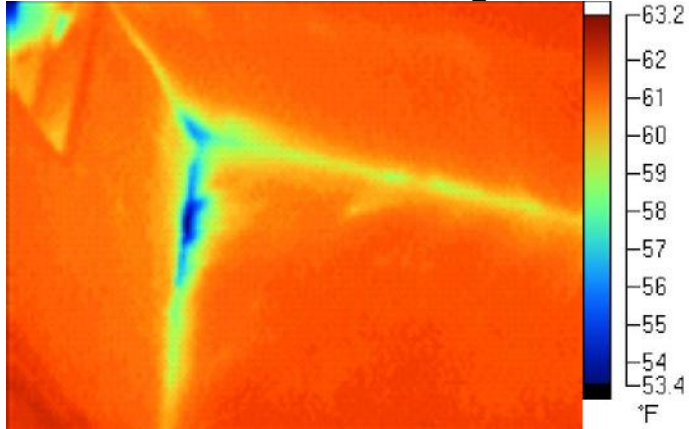
IR20110331_0881.is2

Top of west clerestory wall. WITH blower door running. Coldest spot is 52 deg.F with rest of wall at about 62 deg.F

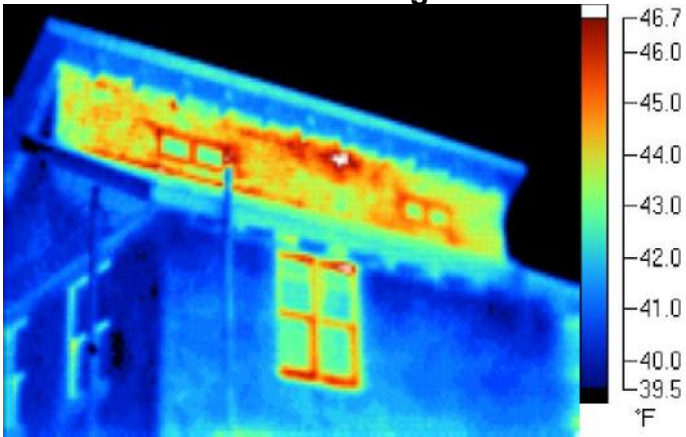
IR20110404_0924.is2

Heat loss at clerestory wall (facing east). Warmest spot is 47 deg.F, at top of wall. Blower door is NOT running.

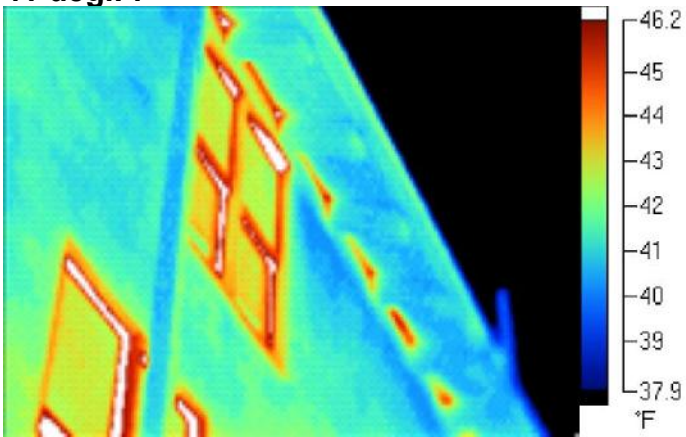
IR20110404_0930.is2

Heat loss at eaves of east facing clerestory. Blower door is NOT running. Warmest spot at eaves is 48 deg.F (ignore windows), while rest of wall is about 41 deg.F.

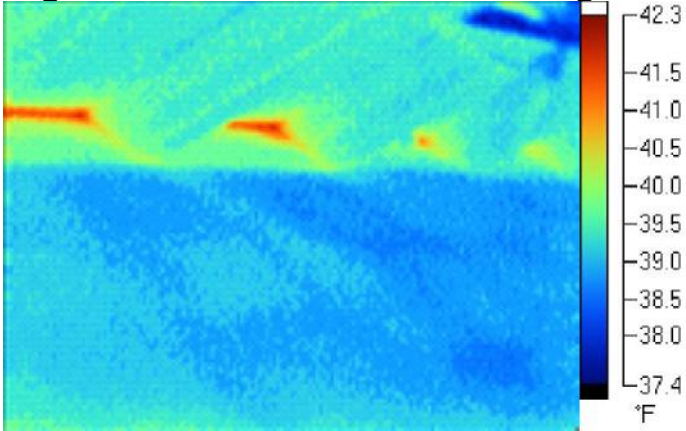
IR20110404_0905.is2

Heat loss at eaves of west wall, with NO blower door running. Warmest spot is 42 deg.F while rest of wall is about 39 deg.F.

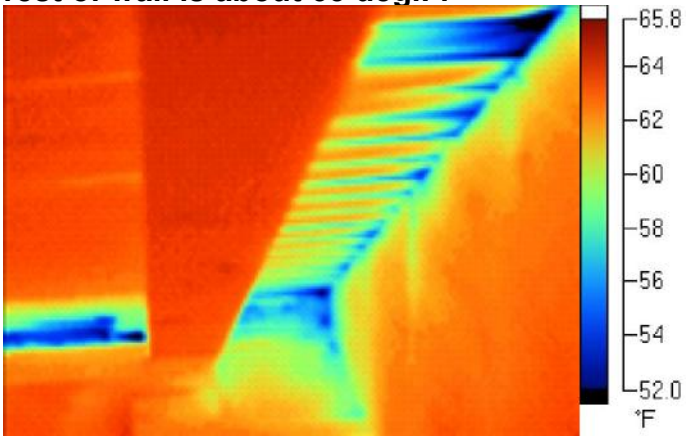
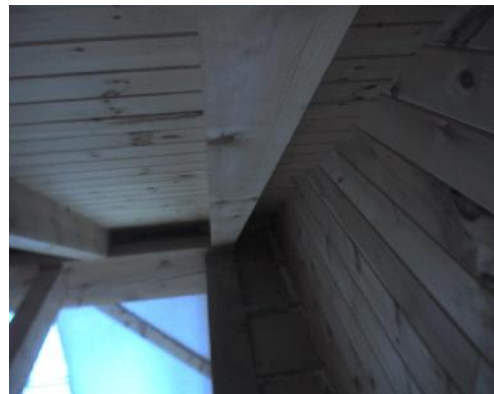
IR20110404_0974.is2

Air infiltration at T&G (joints) in ceiling, looking down on west eaves at north gable end, from inside. Blower door IS running. Coldest spots are 49 deg.F, while rest of wall is about 63 deg.F.

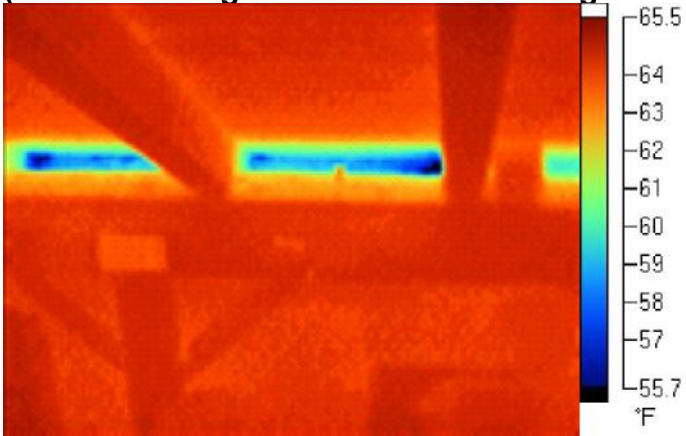
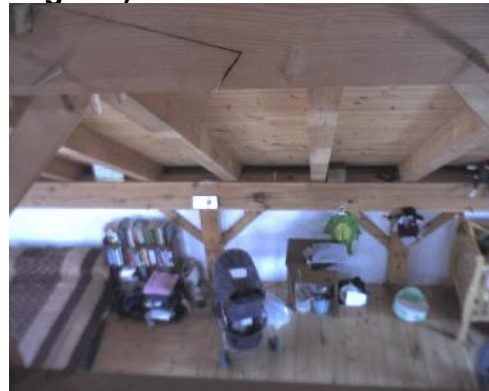
IR20110404_0977.is2

Looking down on west eaves from inside. Blower door is NOT running. Coldest spot is 47 deg.F, while rest of wall is about 64 deg.F.
(see other image from outside showing heat leaking out)

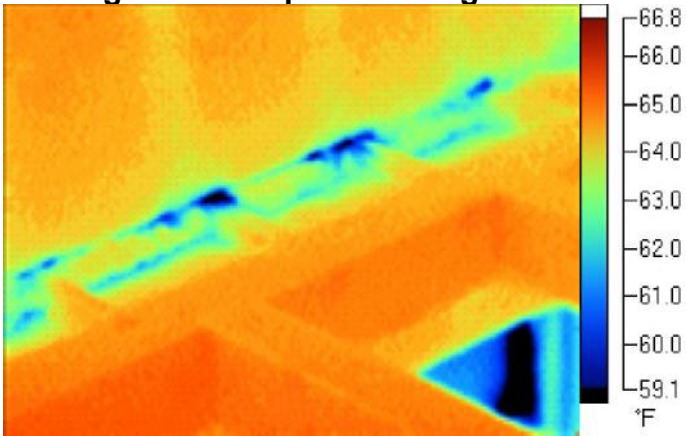
IR20110404_0979.is2

This is the top of the south wall below the clerestory. The gaps here had been foamed with a one-part foam, but several spots were missed. The blower door IS running. Coldest spot is 58 deg.F and rest of wall is at about 64 deg.F.

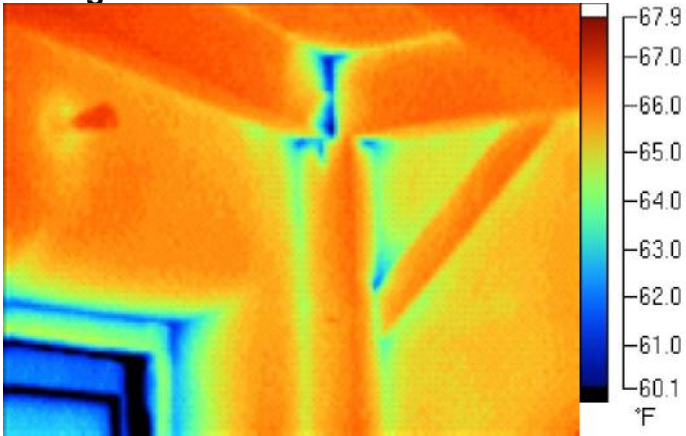
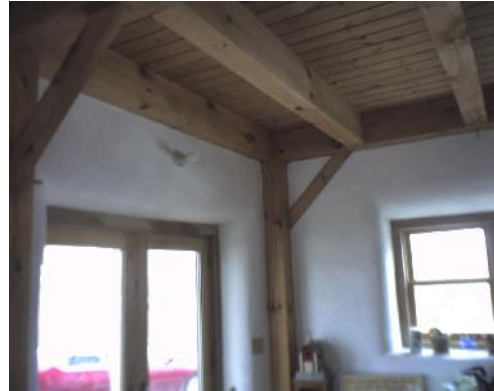
IR20110404_0989.is2

Post and beams at SE corner of 1st floor, WITH blower door running, showing not much air leakage. coldest spot in corner is 59 deg.F and rest of wall is about 65 degrees

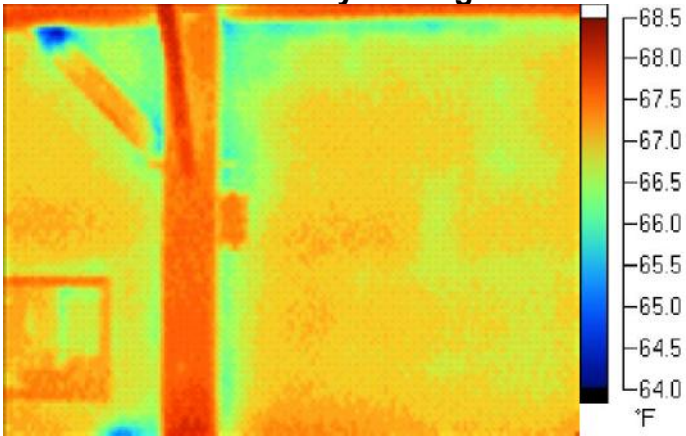
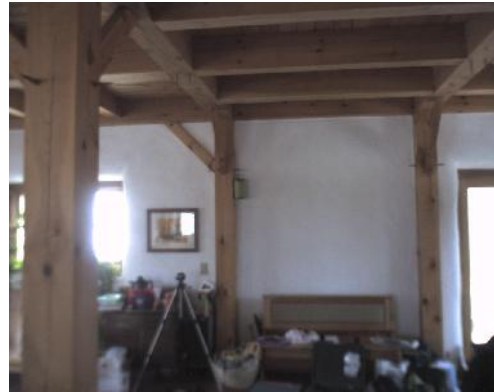
IR20110404_0990.is2

This is the post and beam in the middle of the west wall of 1st floor. The blower door IS running. Coldest spot is 64 deg.F and rest of wall is about 67 deg.F. The thermal window is only 4.5 degrees. This shows little air infiltration!
