Final Report for Energy Performance of Straw Bale Buildings Research Program

December 12, 2011

Final Report for Energy Performance of Northeast Straw Bale Buildings Research

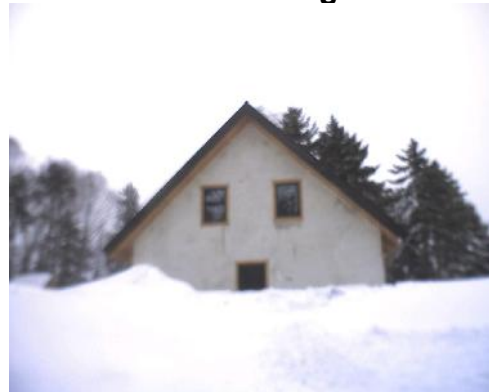
IR20110310_0459.is2

Warm air exfiltrating at top of gable wall – blower door is NOT running

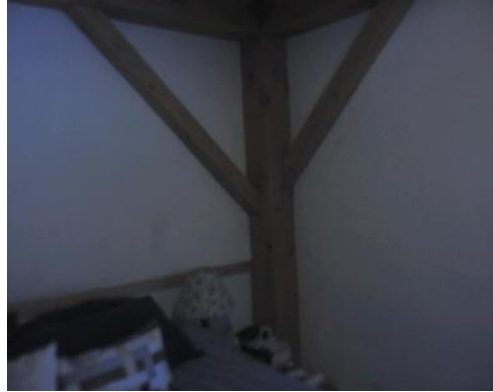
IR20110310_0463.is2

This is a corner post, without the blower door running. The coldest spot is about 64 deg.F.

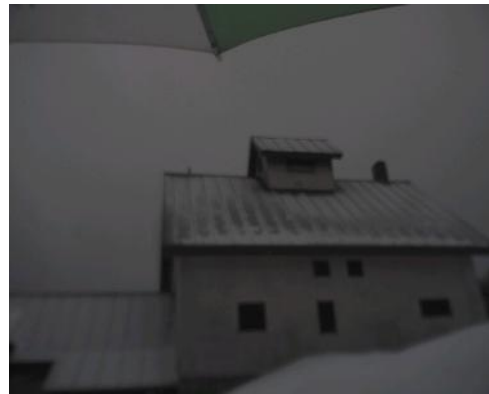
IR20110316_0531.is2

Heat loss at cupola and vent stack pipe. Blower door is NOT running. Warmest spot is 44 deg.F.

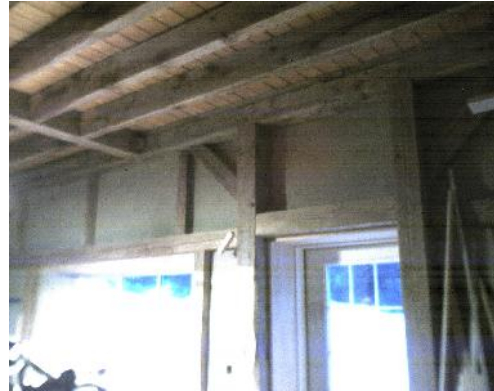
IR20110316_0717.is2

South wall framing above door, with blower door NOT running. Coldest spot is 53 deg.F.

(also see image WITH blower door running)

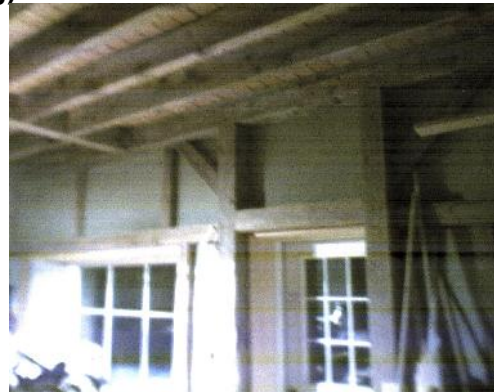
IR20110316_0749.is2

South wall framing above door, blower door is running. Coldest spot is 48 deg.F.
(see other image WITHOUT blower door running)

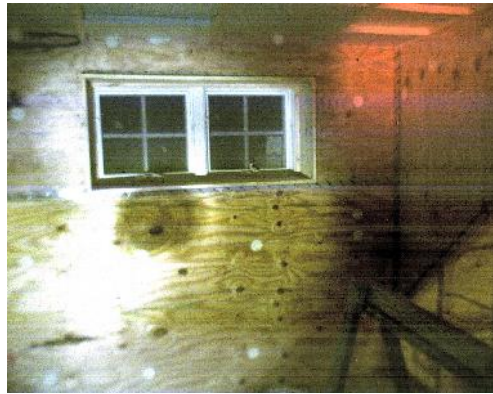
IR20110316_0761.is2

This area below an upstairs (north) window is about 5 deg.F below the surrounding wall, with the blower door running. The rough opening for the window had been made smaller. It may be an indication that the small framing space did not get properly dense-packed with cellulose.

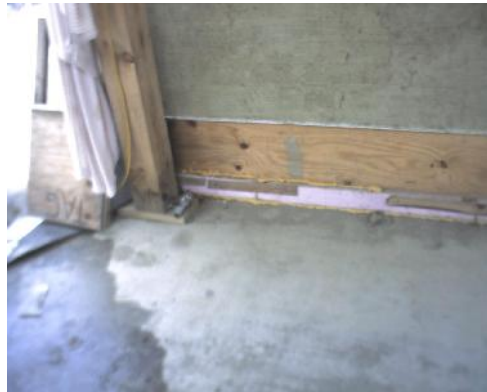
IR20110331_0843.is2

Heat loss at top of stem wall, which is sitting several inches above the concrete slab of carport. Warmest spot is 46 deg.F, while rest of wall is about 41 deg.F (blower door is NOT running)

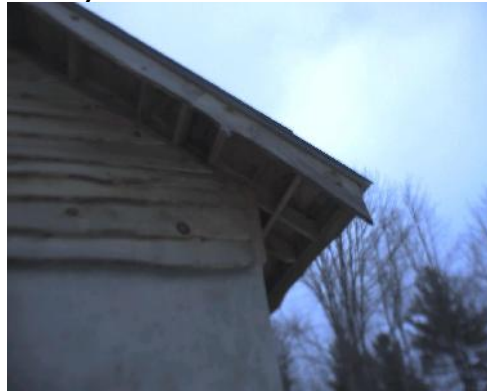
IR20110331_0862.is2

Heat loss at rake, top of east gable wall. Blower door is NOT running. Warmest spot is 57 deg.F, while rest of wall is about 45 deg.F. (This is an 18" deep wall with dense-packed cellulose)

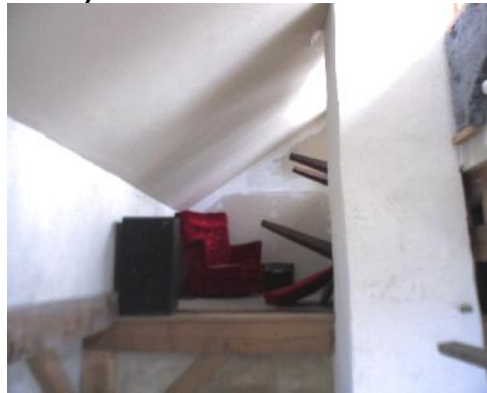
IR20110331_0877.is2

Top of east gable wall (this is the interior view of where heat loss was seen at exterior rake above), with blower door NOT running. Not a lot of temperature difference here. Coldest spot is 60 deg.F, with rest of wall at about 63 deg.F. (This is an 18" deep wall with dense-packed cellulose)

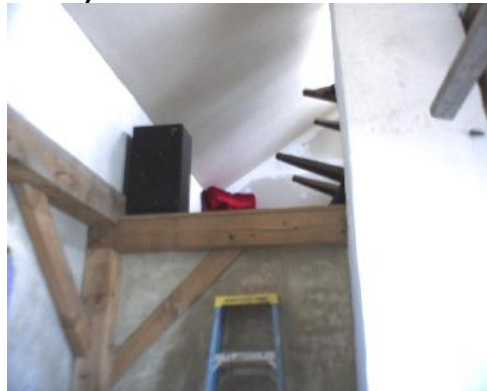
IR20110331_0878.is2

Same east gable end wall, WITH blower door running. Now the coldest spot is 58 deg.F with the rest of the wall at about 62 deg.F. Not a big change with the blower door running.

(This is an 18" deep wall with dense-packed cellulose)

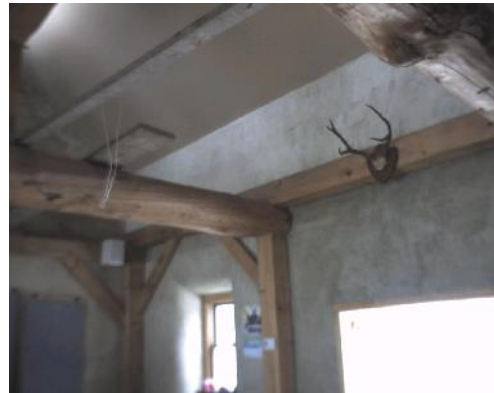
IR20110331_0868.is2

This is the post and beam in the middle of the north wall, with NO blower door running. Maximum temperature difference of wall in this area is only 2 degrees, which is not significant.

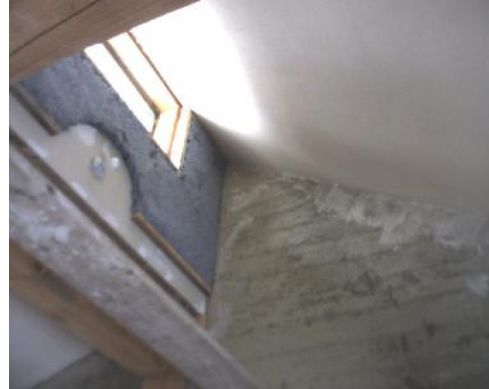
IR20110331_0881.is2

Top of west clerestory wall. WITH blower door running. Coldest spot is 52 deg.F with rest of wall at about 62 deg.F

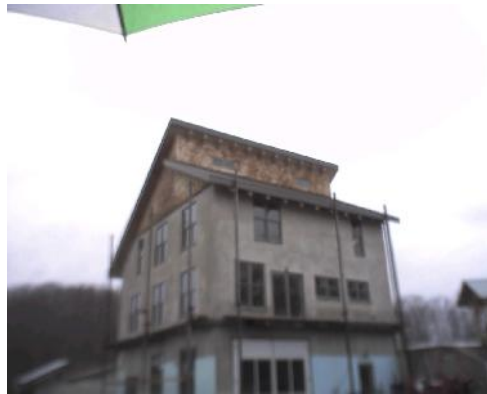
IR20110404_0924.is2

Heat loss at clerestory wall (facing east). Warmest spot is 47 deg.F, at top of wall. Blower door is NOT running.

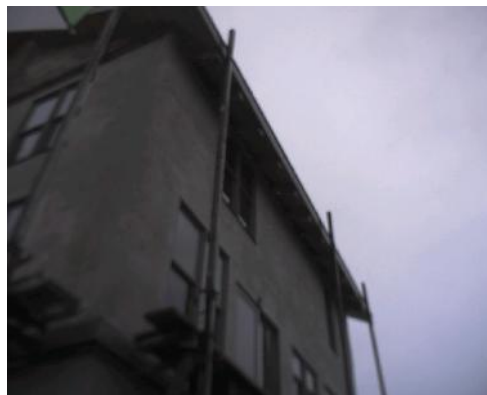
IR20110404_0930.is2

Heat loss at eaves of east facing clerestory. Blower door is NOT running. Warmest spot at eaves is 48 deg.F (ignore windows), while rest of wall is about 41 deg.F.

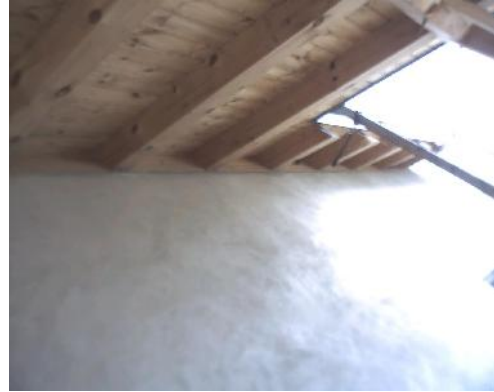
IR20110404_0905.is2

Heat loss at eaves of west wall, with NO blower door running. Warmest spot is 42 deg.F while rest of wall is about 39 deg.F.

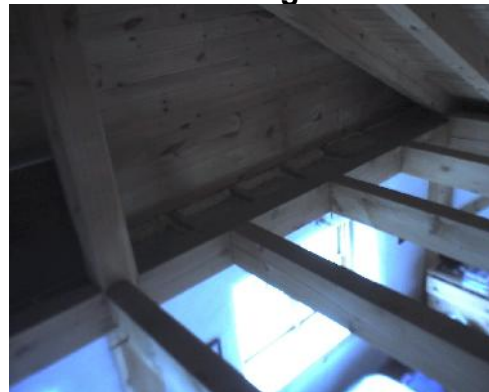
IR20110404_0979.is2

This is the top of the south wall below the clerestory. The gaps here had been foamed with a one-part foam, but several spots were missed. The blower door IS running. Coldest spot is 58 deg.F and rest of wall is at about 64 deg.F.
